TECHNICAL TOPICS

CHOOSING A REMANUFACTURED STEERING GEAR

By Doug Leno

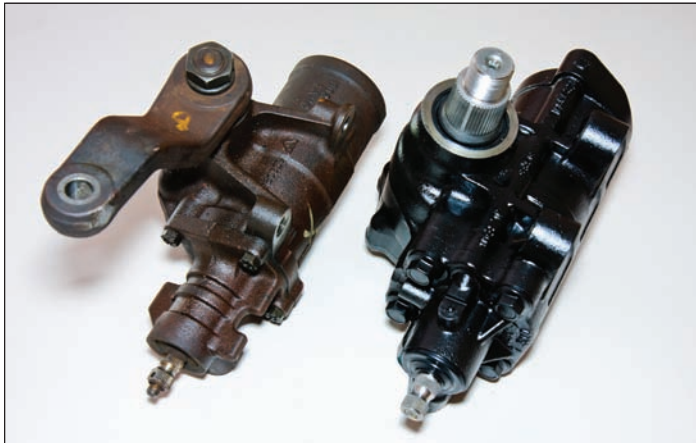
On the left is the original steering gear supplied on new 2003-2008 trucks. The 50% heavier Mopar replacement gear (right), part number 68170214AA, was introduced in 2011.

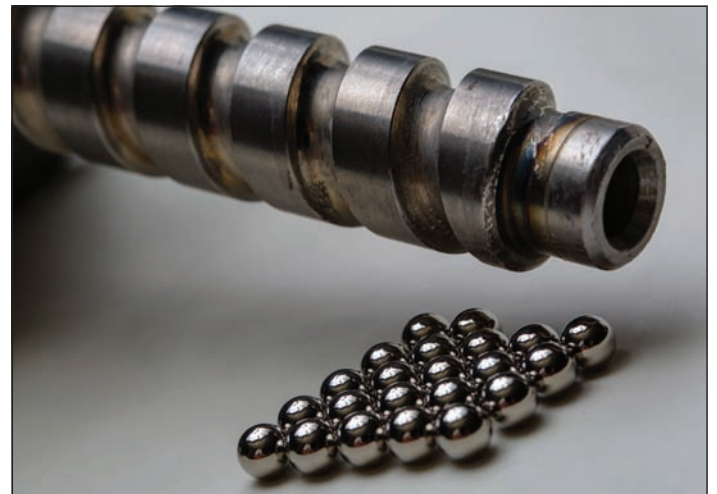
The ball screw assembly arguably has the most influence upon steering slop of any subsystem in the gear. Consider the set of ball bearings (shown in Figure 5) which ride inside of the screw's helical raceway: If the bearings are too small, then the screw will rotate before the bearings engage the piston, which will cause steering slop or play at the steering wheel. On the other hand, if the bearings are too large, the assembly will bind. There is a direct connection between the steering wheel and the ball screw so the driver feels any of the ball screw slop. This is magnified by the diameter of the steering wheel! According to RedHead, undersized bearings are the most common problem in mass produced gears, accounting for about 70% of my steering slop. This slop cannot be adjusted out—it is the natural consequence of mismatched parts.

Figure 5. RedHead replaces the entire set of recirculating ball bearings with custom-fit bearings to eliminate slop. The standard steering gear, part #2879 (shown here), utilizes 22 bearings. The 46-pound "Mopar Upgrade", part #2879U, utilizes 27 bearings.

I was pleased to discover that RedHead replaces the entire set of factory-supplied ball bearings with their own proprietary bearings, custom sized for each gear they build. While mass produced steering gears rely on a "one bearing size fits all" assembly, RedHead chooses the bearing that best fits the raceway. This is the only way to eliminate ball screw slop.

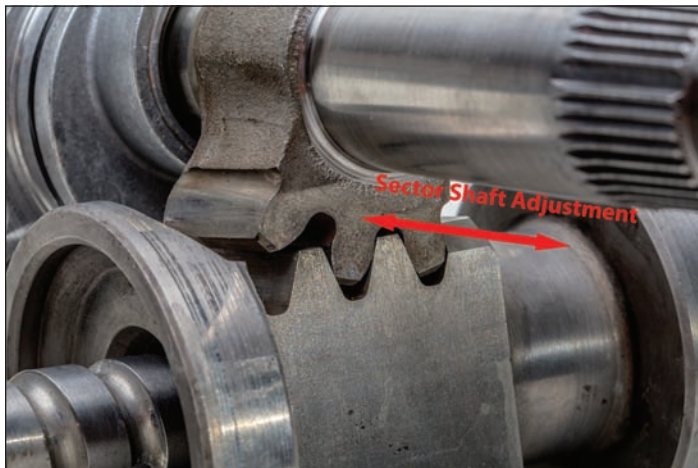
The second big contributor to steering slop is the gear lash between the sector shaft teeth and the piston teeth. In a properly manufactured steering gear, this lash is adjusted out as illustrated in Figure 6.

During the remanufacturing process, RedHead found that my gear's "hard parts" were in essentially new condition, but that the gear lash adjustment had been incorrectly performed, accounting for the remaining 30% of my reported steering slop.

Figure 6. The Sector shaft is adjusted with respect to the piston for minimum gear lash without binding.

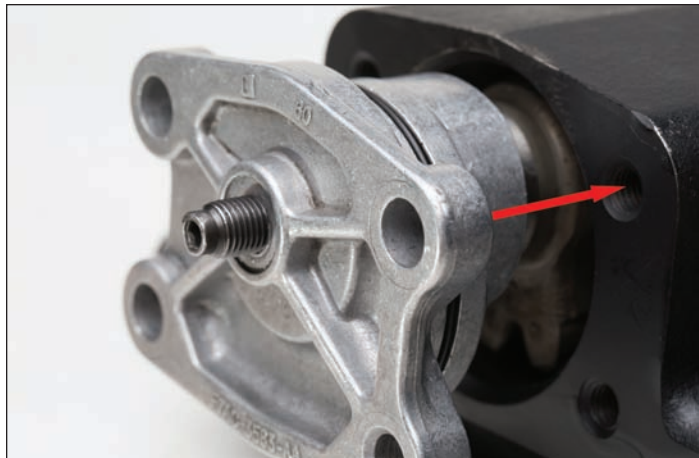
To illustrate the tedious nature of proper lash adjustment, I photographed the standard (original) Mopar gear as it might appear during the lash adjustment process: Consider Figure 7, where you can see the sector shaft teeth located just inside of the black housing (bottom right, in the photograph). Notice that the end cap has been screwed onto the threaded adjustment end of the sector shaft—the number of turns precisely locates the sector shaft with respect to the piston inside the housing. To adjust gear lash, a technician will give the end cap one turn, install the assembly onto the housing, test the gear, and then repeat the process until achieving that magic point of minimum lash before binding.

Figure 7. Gear lash on the original Mopar gear, RedHead part #2879, is adjusted one turn at a time. The same adjustment for RedHead part #2879U (Figure 2) is made with an external adjustment screw.

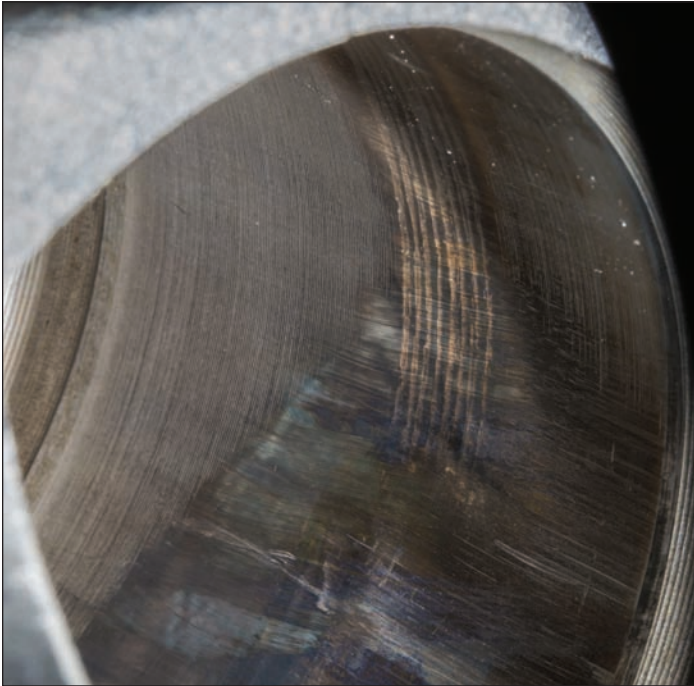
When you are in the remanufacturing business you see all kinds of interesting failure points of the steering gear. One example is shown in Figure 9. Notice the uneven wear on the housing that encloses the piston. This type of wear is common in the standard gear, and greatly accelerated by oversized tires and lifted suspensions with dropped pitman arms. Sloppy internal tolerances are also a factor. Tyler informed me that the housing shown in Figure 9 will be scrapped, along with the piston, which showed corresponding wear as well.

Figure 9. This housing will be replaced, due to uneven wear.

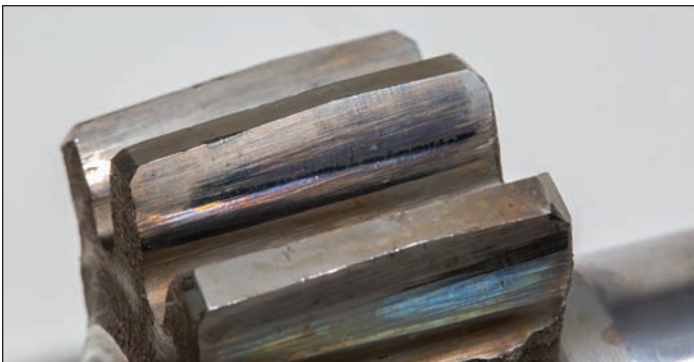
Another failure point is the piston and sector shaft teeth themselves. As astute Turbo Diesel owners, we might notice the heat generated by the power steering gear and pump, but we rarely stop to appreciate the tremendous forces present inside of the steering gear itself. Consider the sector shaft teeth, for example, which endure all the forces required to hold and turn the wheels. Properly lubricated and adjusted, these teeth can take it; otherwise they end up like the photo in Figure 10.

Figure 10. Excessive wear on the sector shaft teeth: this one is headed for the scrap bin.
