TECHNICAL TOPICS

CHOOSING A REMANUFACTURED STEERING GEAR

By Doug Leno

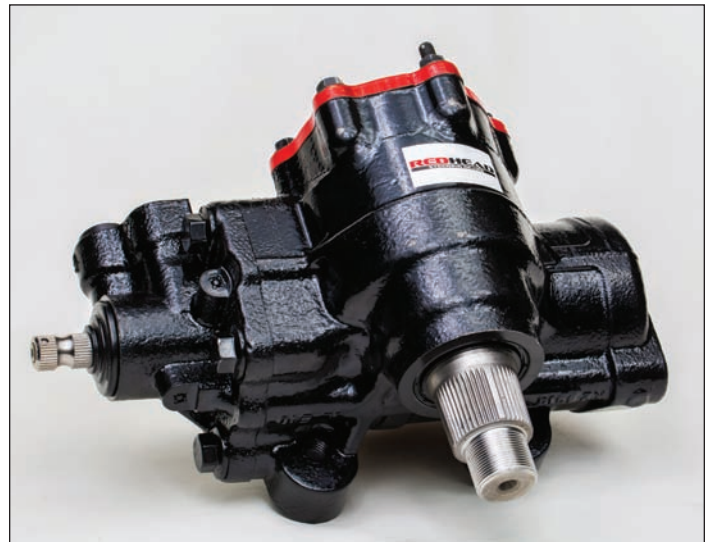
Figure 2. The Redhead Steering gear, part #2879U, which is based on Mopar part #68170214AA

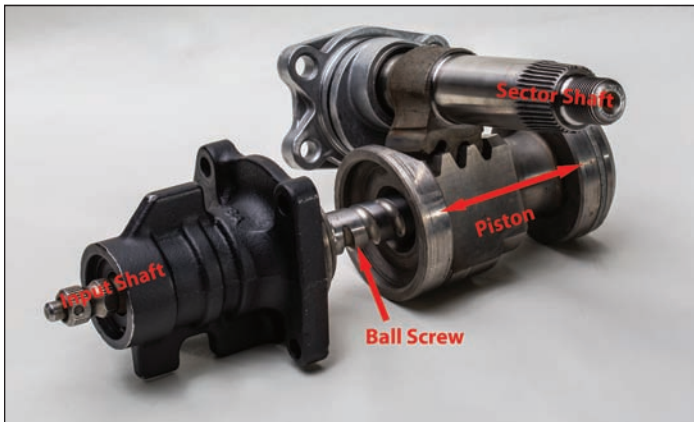
Figure 3. Essential steering gear components, shown without the housing that holds everything together: The input shaft (far left) rotates the ball screw (center), which moves the piston (far right) which rotates the sector shaft (top).

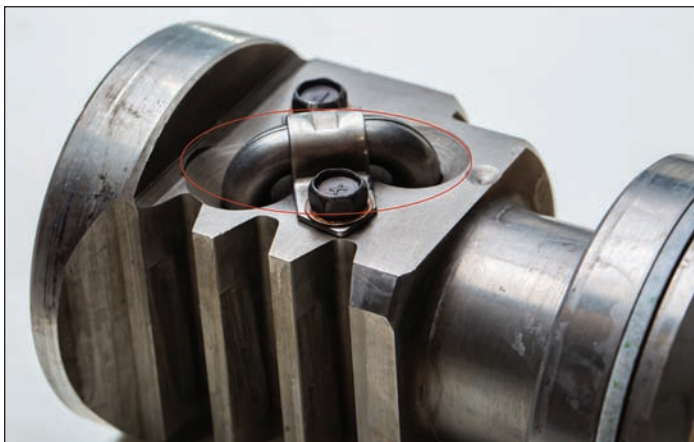
Figure 4. The ball bearings "stay in the piston" while it moves back and forth along the ball screw by passing through the recirculation tube (circled).

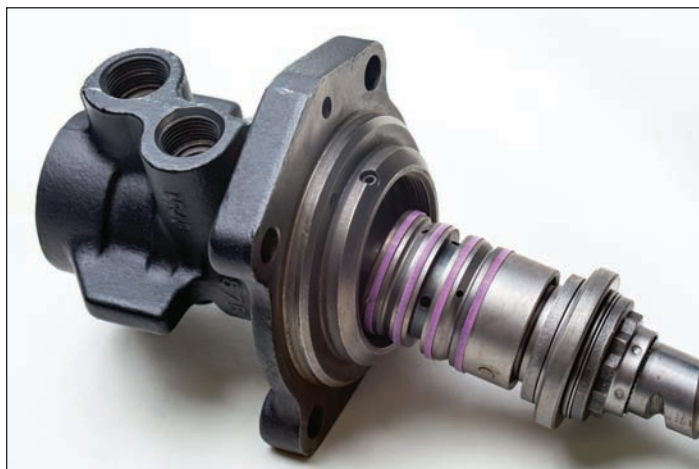
The flow of power steering fluid is controlled by a rather complex set of seals, parts, and passageways within and surrounding the input shaft and the mating surfaces of the housing (see Figure 8). This is where the "magic" happens—rotation of the input shaft also rotates the valve assembly which directs high pressure fluid where it is needed to assist piston movement. RedHead replaces all the seals and accompanying parts as required to guarantee new valve performance. They bench test every gear to verify correct power assist behavior.

Figure 8. The magic of power steering assist is accomplished by a set of seals, parts, and passageways on the input shaft and mating surfaces of the housing.
